THE RED WATERFALL

Demonstrating acid mine drainage

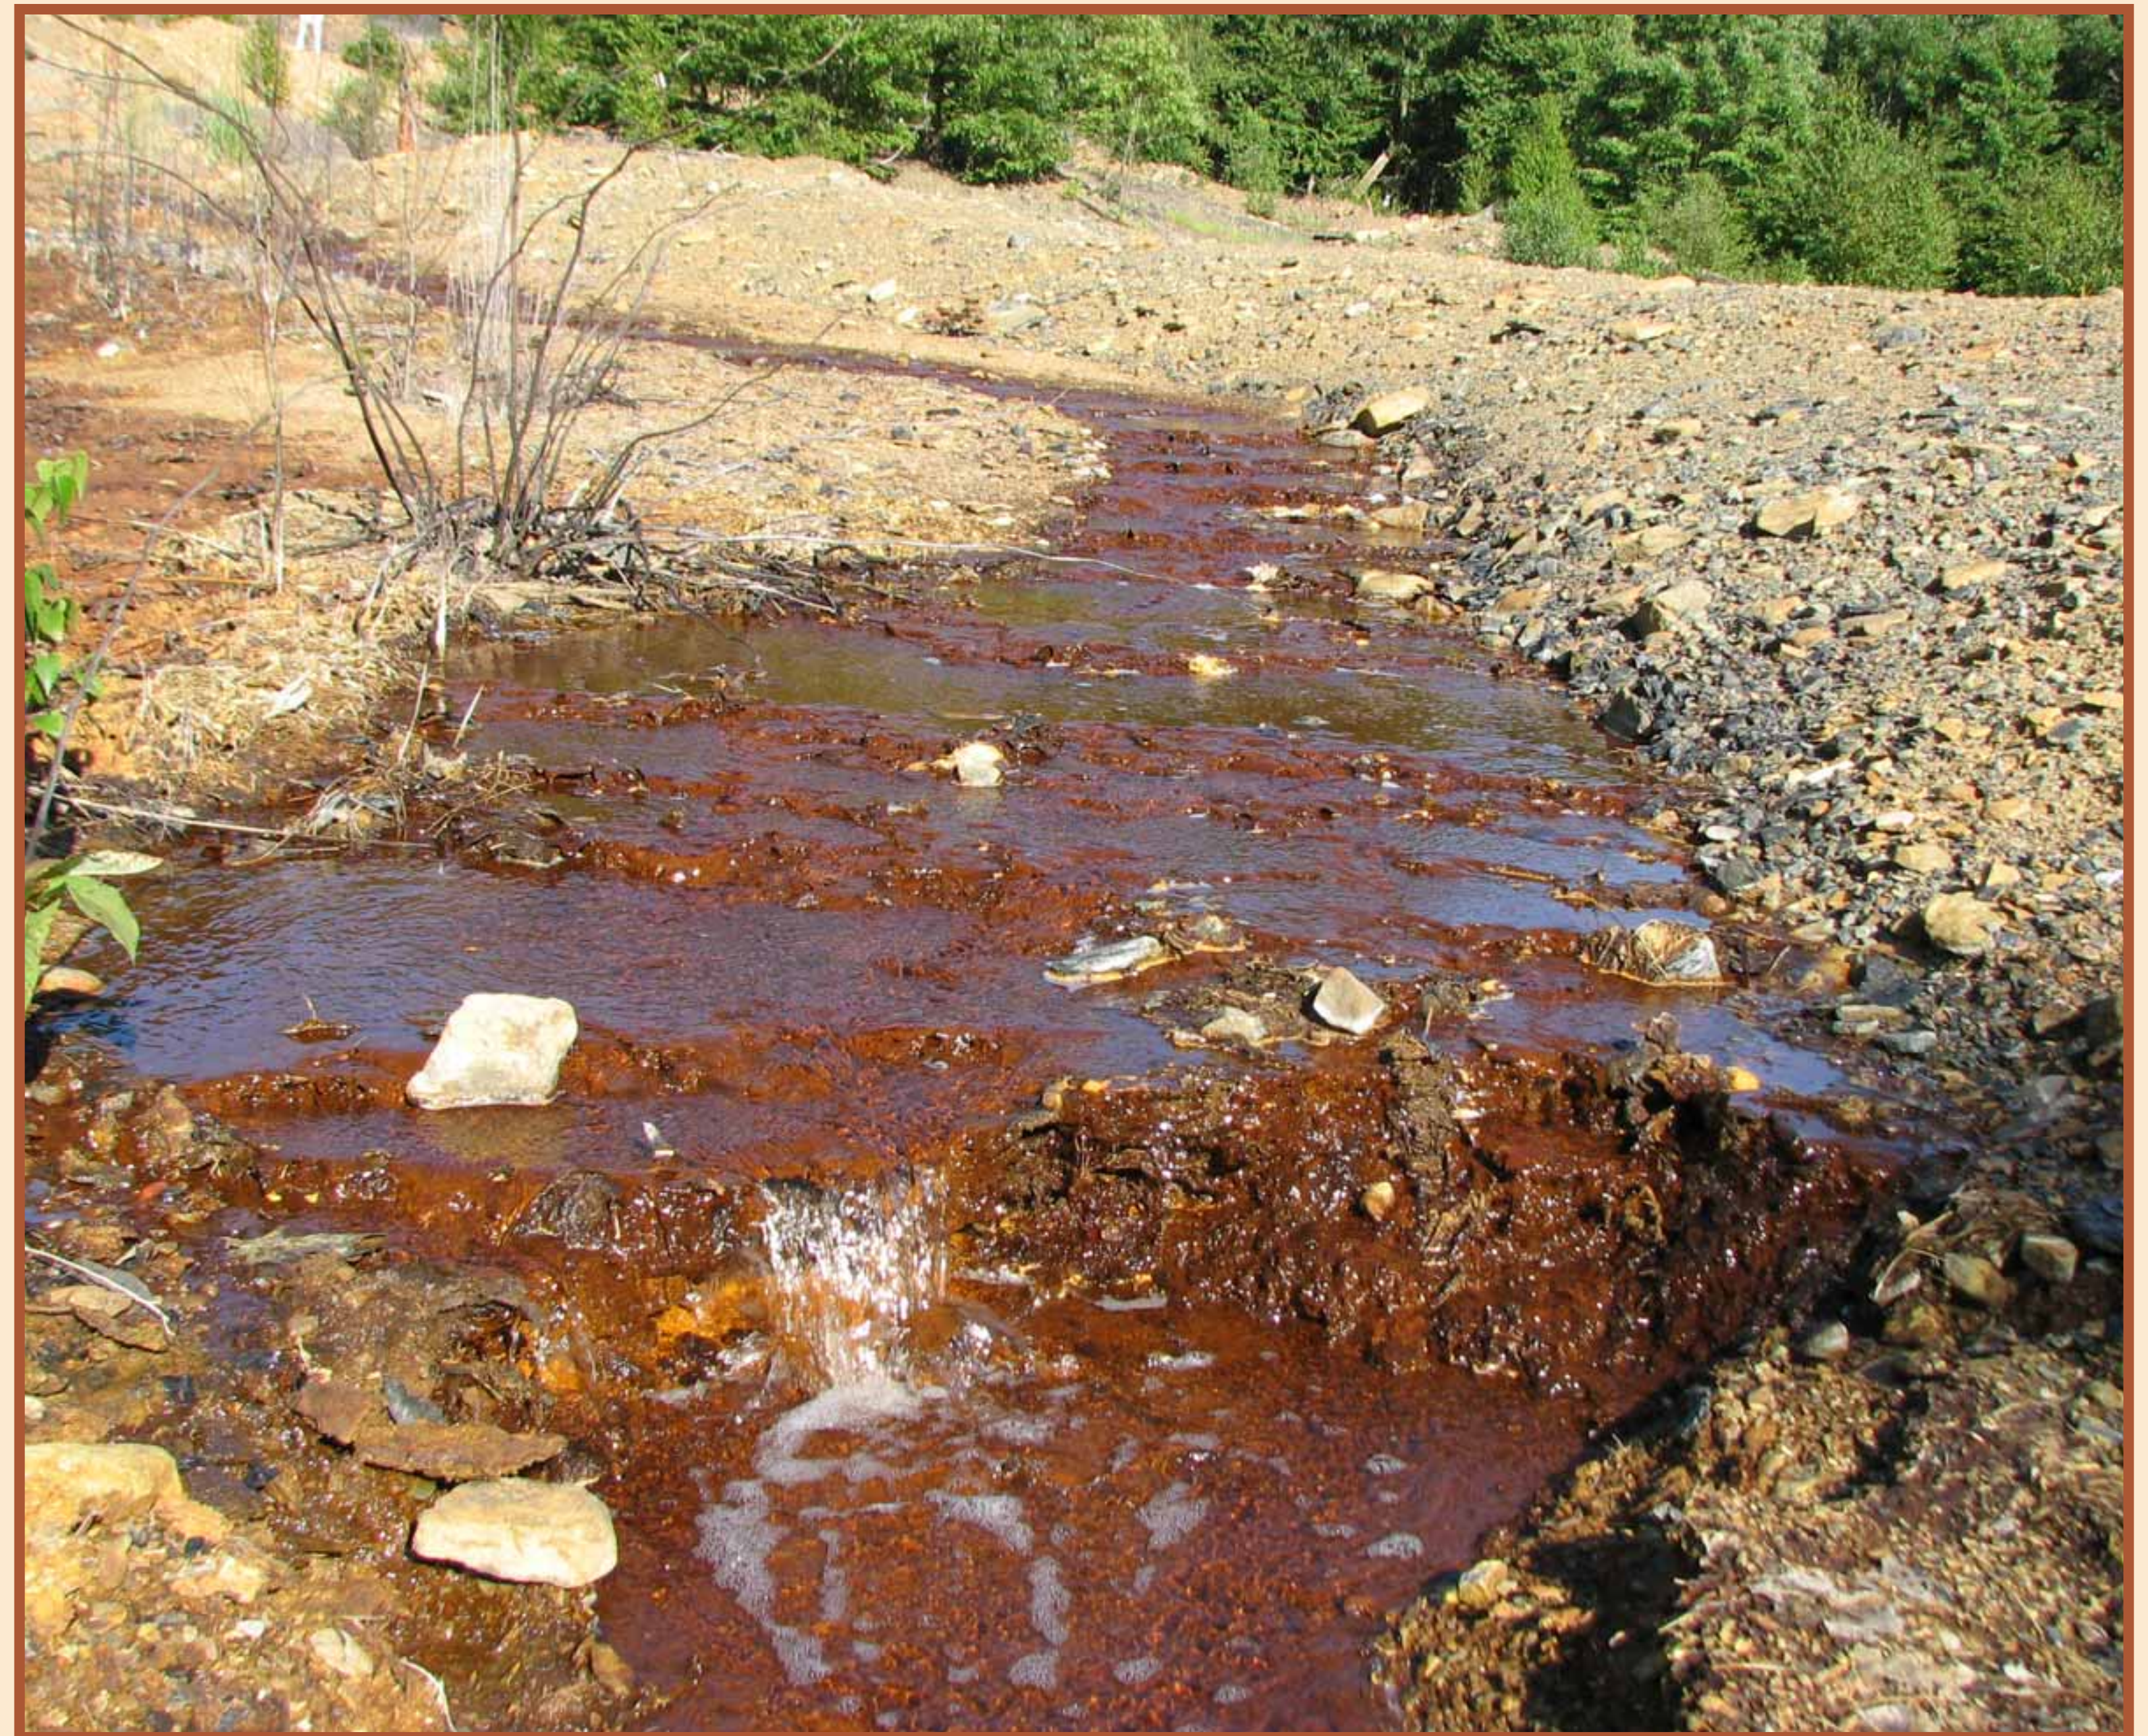
Acid mine drainage mars the landscape and impacts water quality.

The water here is acid and iron-rich, coming up to the surface from underground mines, staining the rocks rust-red. Acid mine drainage (AMD) is a major source of water pollution and the cause of extensive stream degradation and environmental damage.
